**CHAPMAN LAKE
DIAGNOSTIC STUDY
Kosciusko County, Indiana**

June 8, 2001

CHAPMAN LAKES DIAGNOSTIC STUDY EXECUTIVE SUMMARY

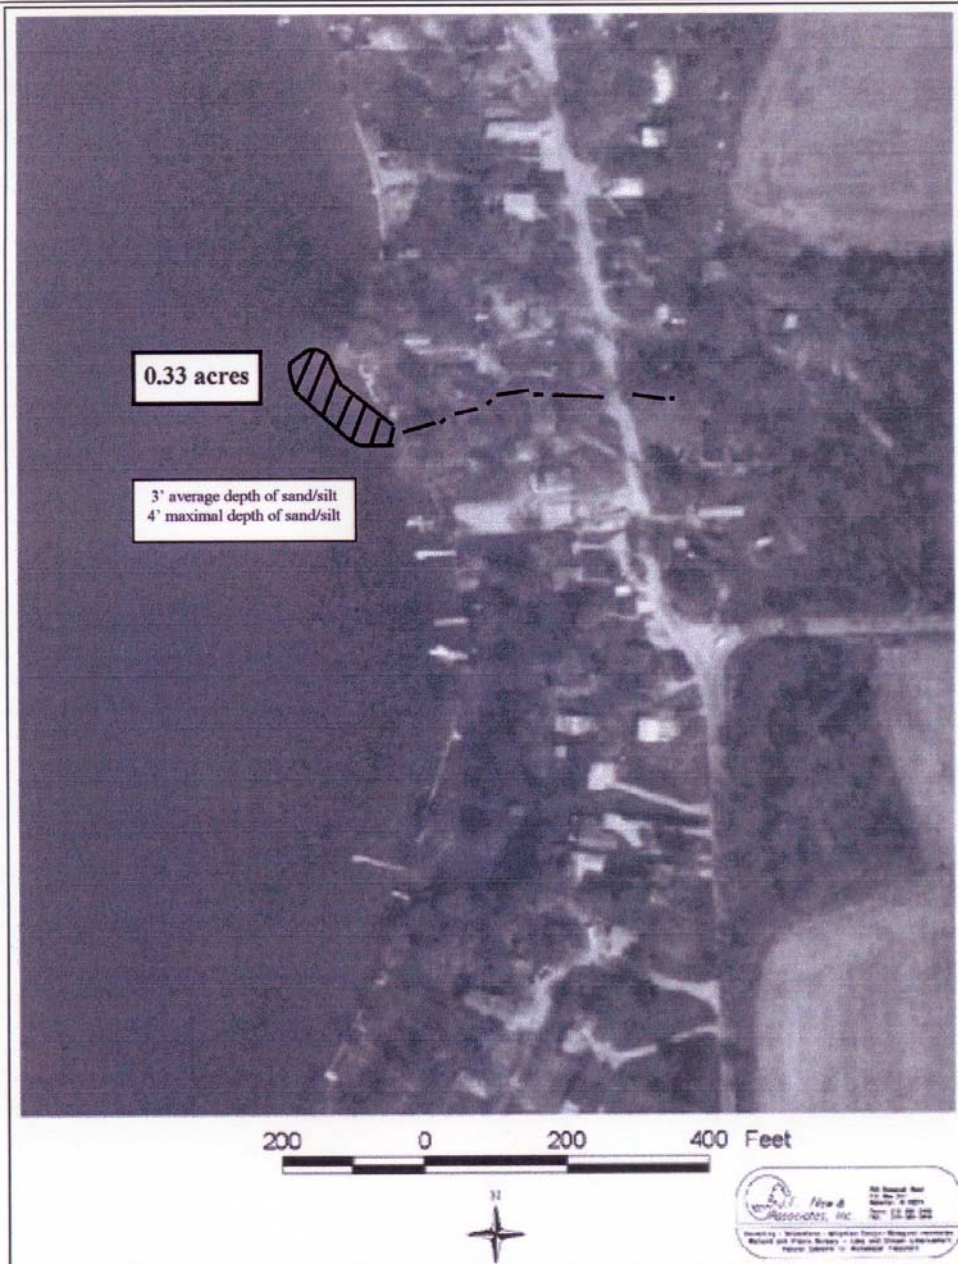
Figure 4: Area 4 – Highland Park Drain
 Dredging Survey
 Chapman Lakes
 Kosciusko County, Indiana
